The Town of Niagara-On-The-Lake

Report: MHC-20-008 **Committee Date: June 23, 2020**

Report To: Municipal Heritage Committee
Subject: 46 Paxton Lane
Heritage Permit Application
Conservation Plan for Paxton House

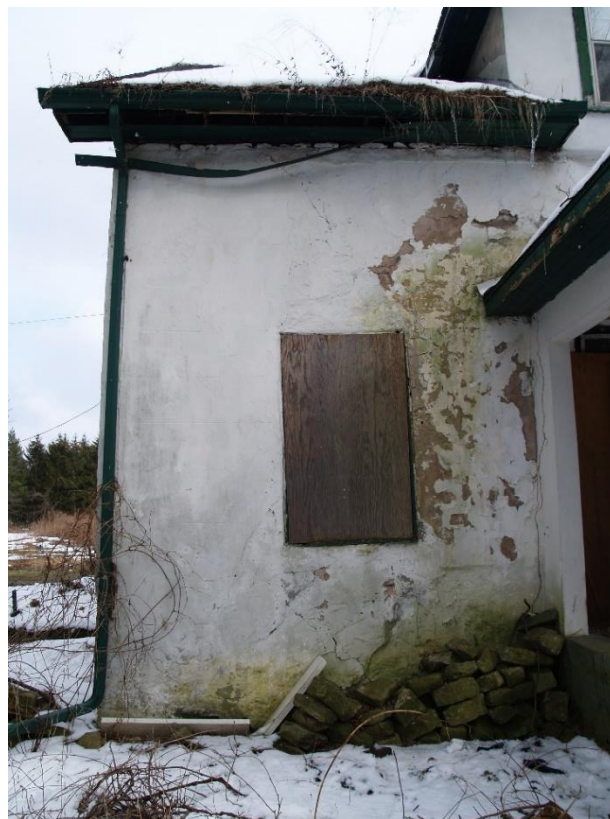
Figure 18: Evidence of wall movement at the northwest corner, just below the window opening (2018).

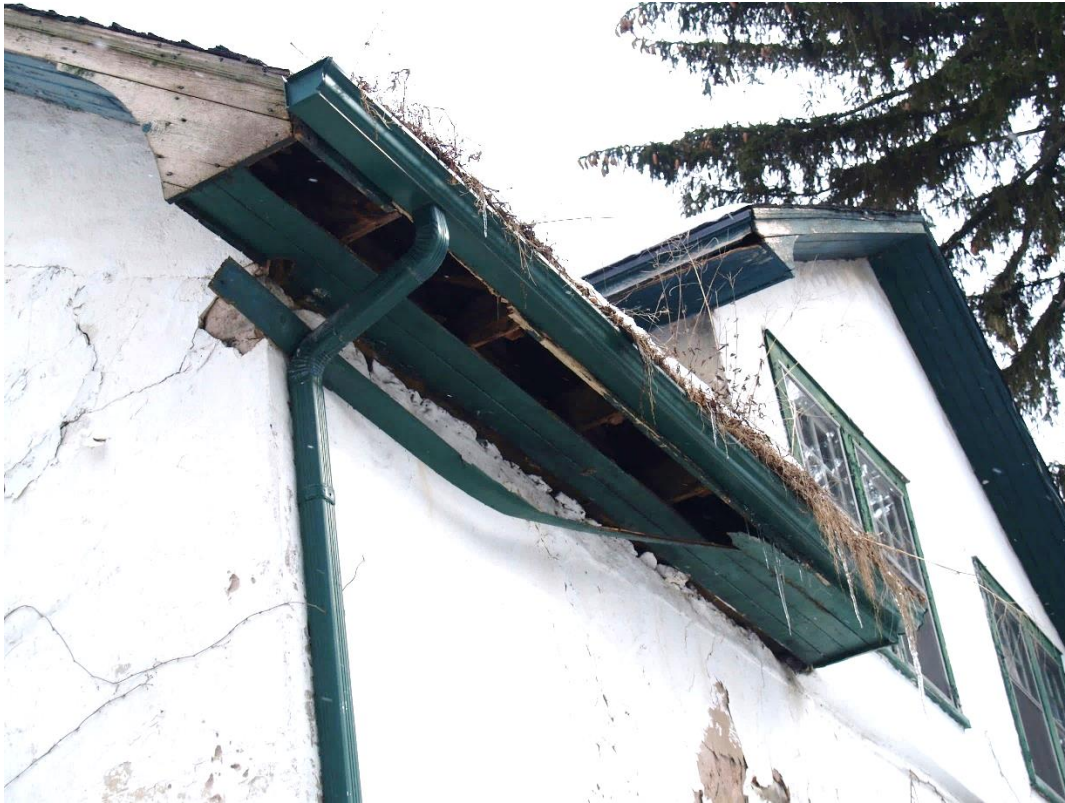
Figure 19: Vegetation growth in the gutter and lost and deteriorated fabric at the soffit (2018).

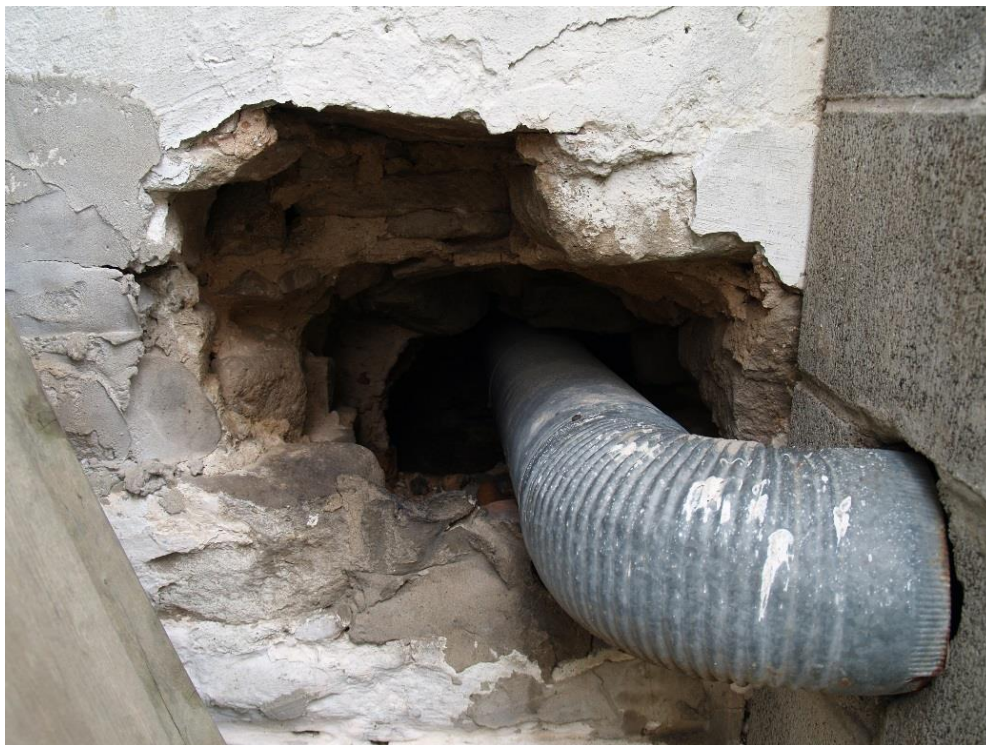
Figure 20: Poorly executed breach in the south end wall (2018).

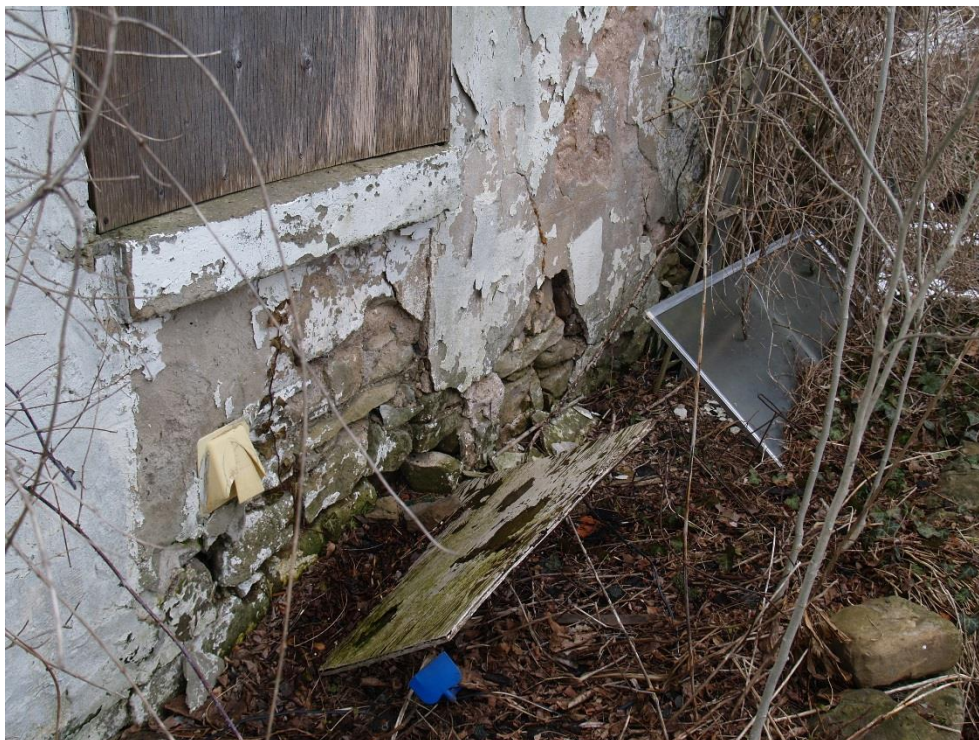
Figure 21: Render failure, mortar washout, and Portland cement repair (far left) under the north window on the east façade (2018).

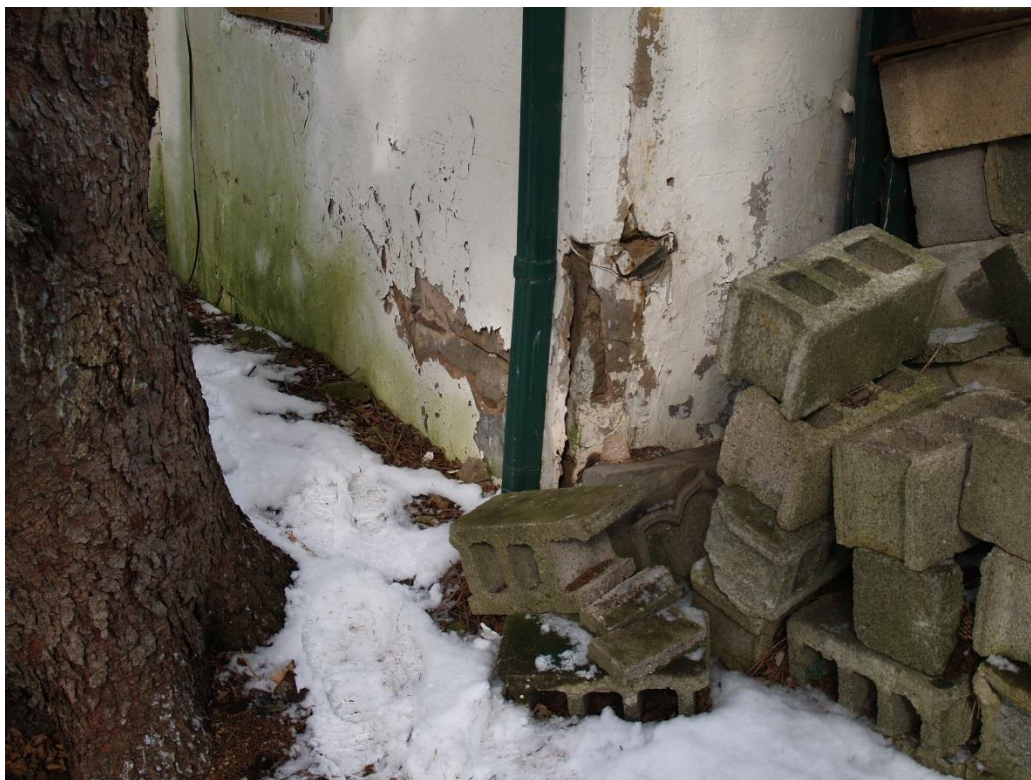
Figure 22: Mature tree growth near the southwest corner. Note spalling on the wall (2018).

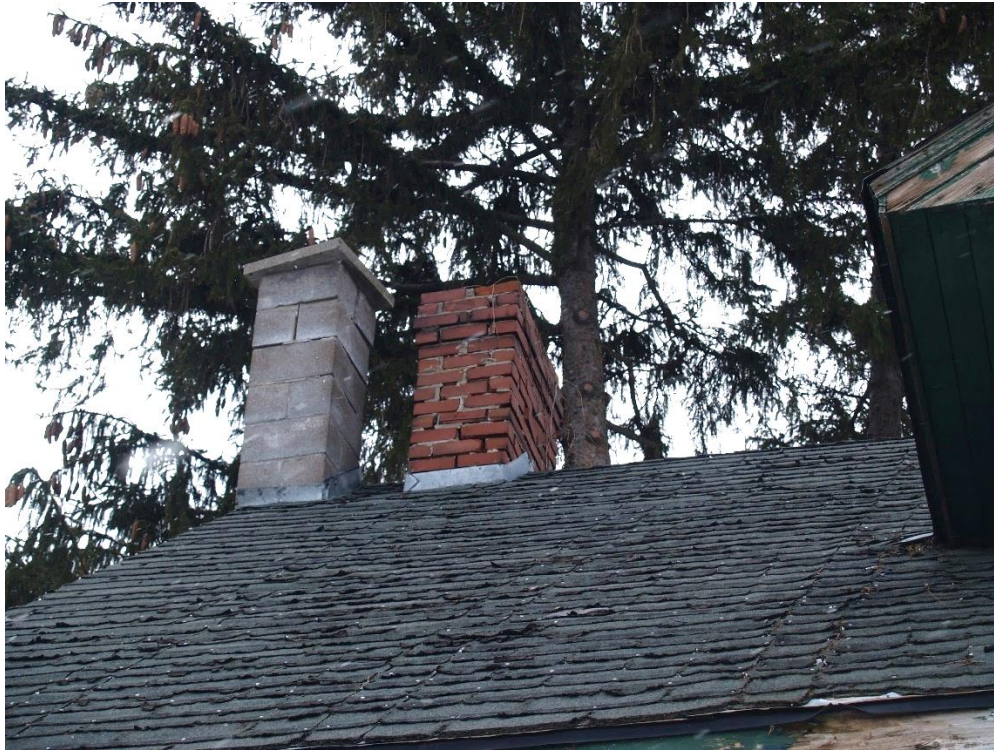
Figure 23: Chimneys in poor condition with inadequate flashing (2018).

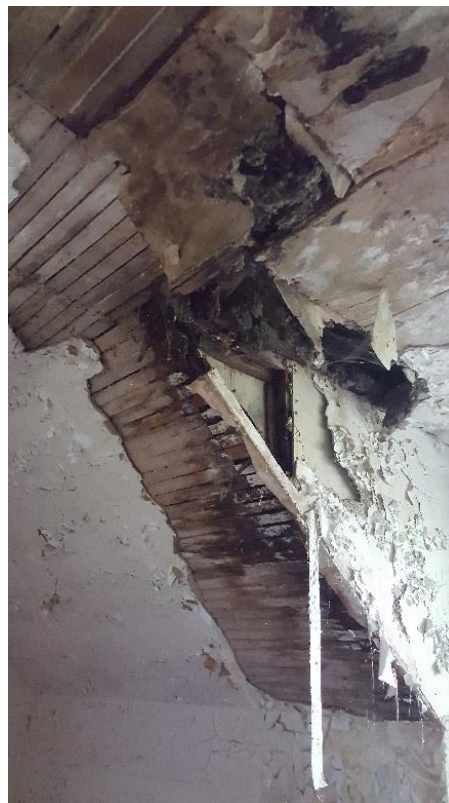
Figure 24: Water infiltration and damage to the lath and plaster surrounding the west dormer (2017).

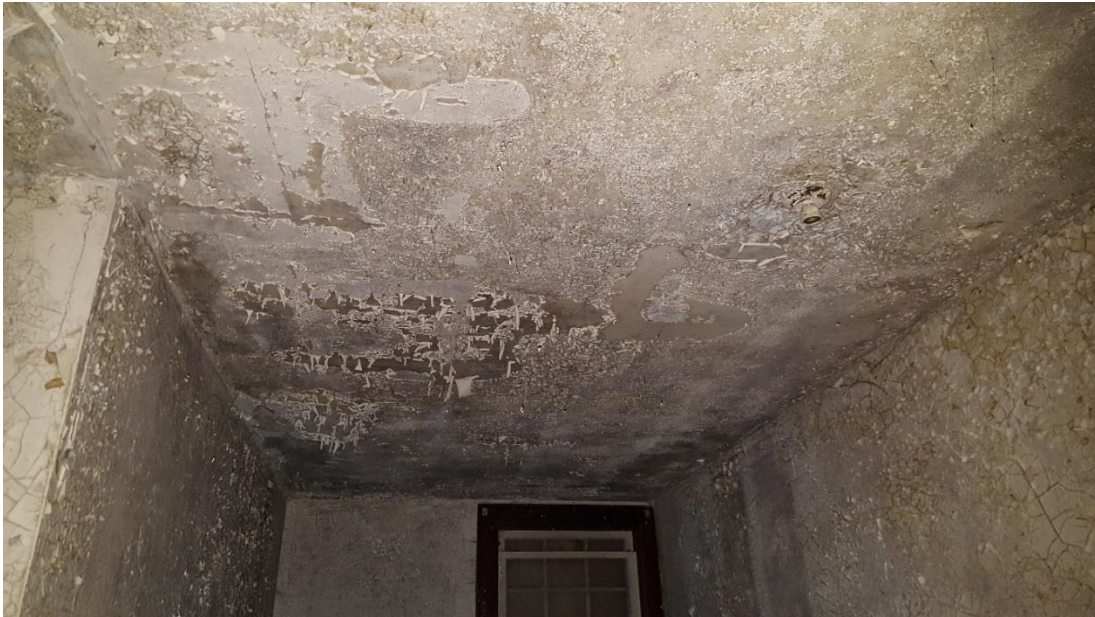
Figure 25: Extensive moisture infiltration in the ceiling of the second level at the staircase (2017).

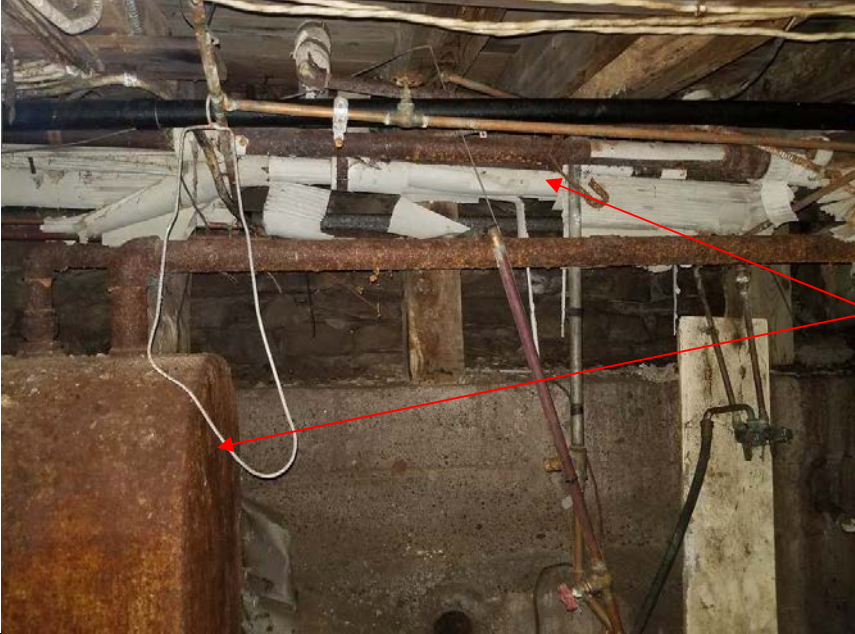
<p>Potential DSHM within the basement: pipe wrap in poor condition, also note an above ground storage tank historically used for heating oil, also in deteriorated condition.</p>
11

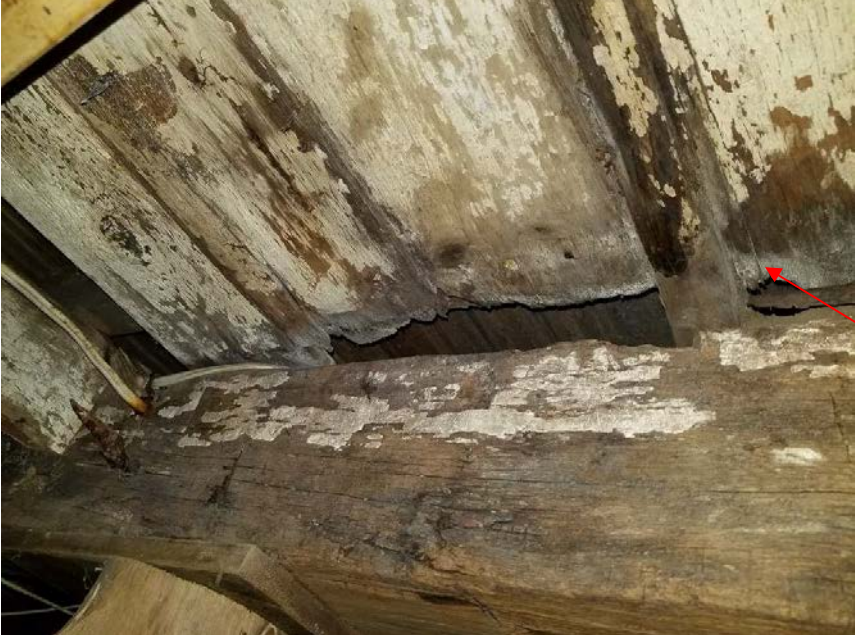
<p>Potential DSHM within the basement: mould along the bottom main floor floorboards & potential lead-based paint.</p>

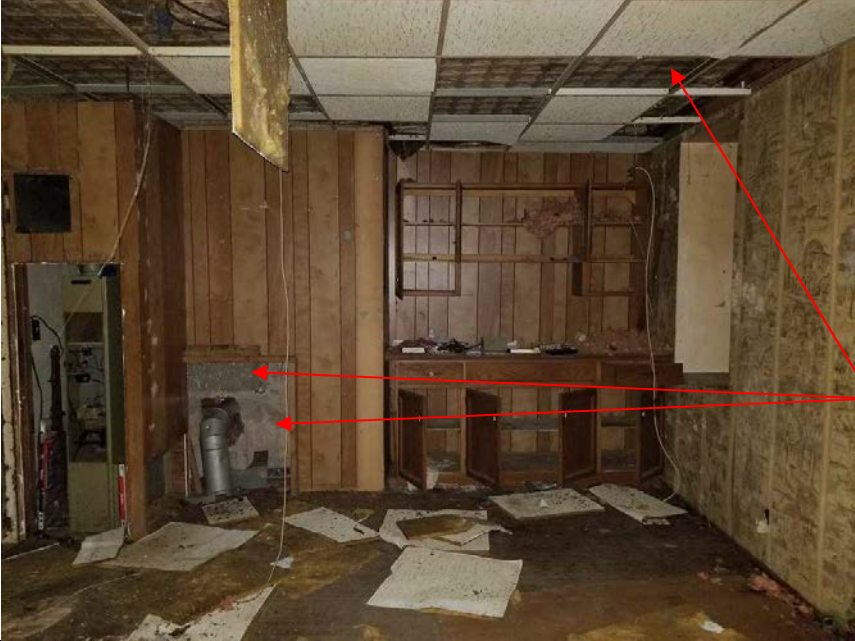
Potential DSHM in dining room on main floor: heat plate, parging & paint on metal ceiling.
13

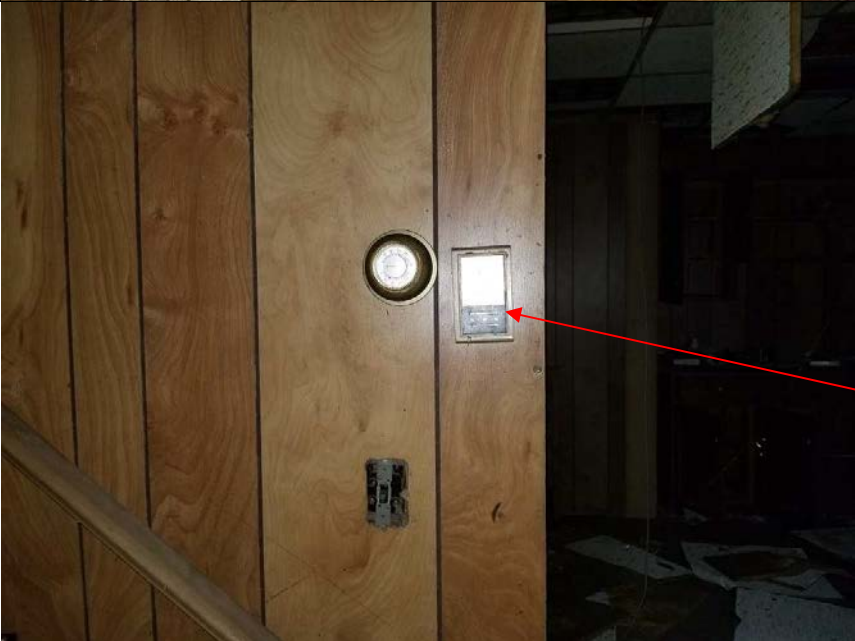
Potential DSHM within the living room on the main floor: Mercury within thermostat.

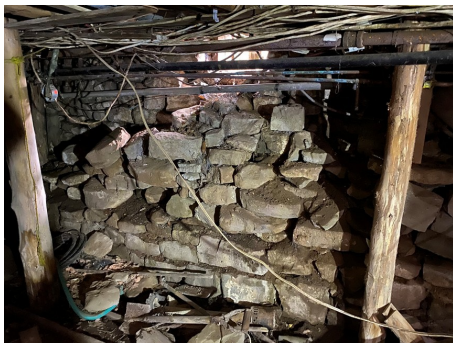
In many areas the mortar joints between the stones in the foundation walls were not present. There were traces of pulverized soil seeping through empty cavities between the stones.

The stone wall without joint mortar

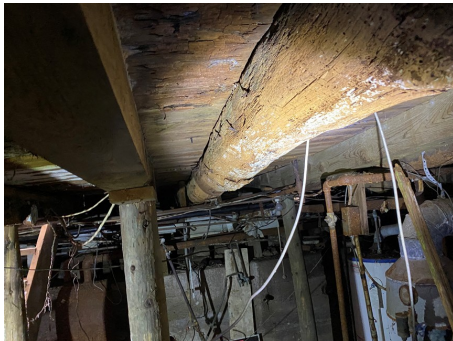
At many locations new vertical wood posts were installed, probably to reduce the increased floor deflection.

Old and new floor joist/post

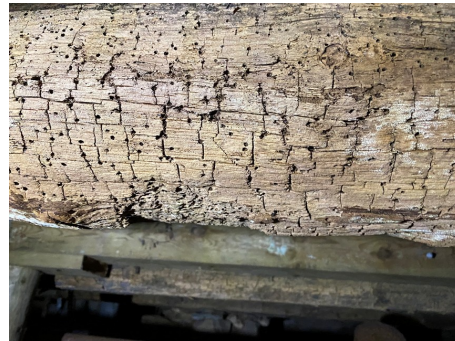
Damaged floor joists

The floor joists are damaged and we can not determine it's capacity. The wood posts are resting on dirt or flat pieces of wood, which is structurally unacceptable.

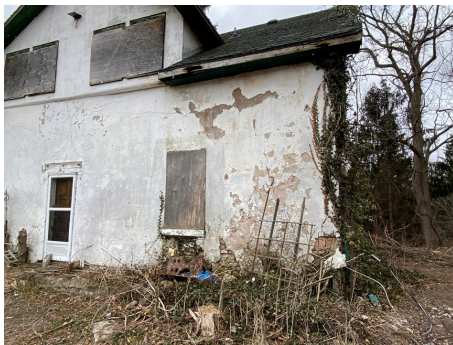
Exterior house walls were made out of stone and parged. Due to damaged gutters and downspouts the sections of the exterior walls were damaged.

Damaged exterior wall

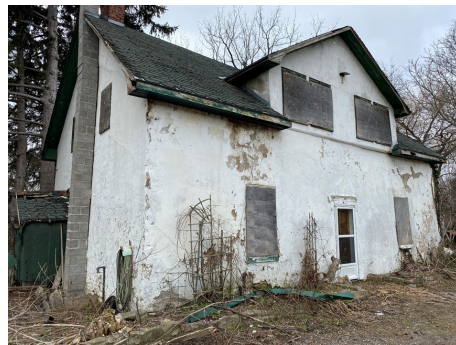
Damaged wall and missing gutter

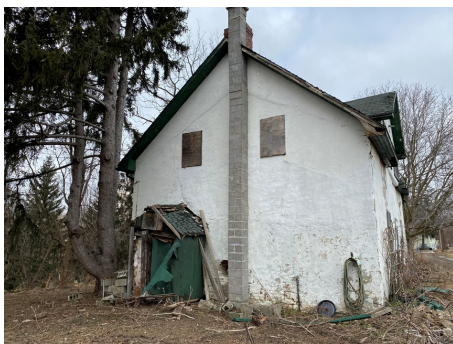
It is obvious from the side elevation that the roof was replaced and reshaped sometime in the past. The dormers were introduced at front and at the back. The roof is in bad shape. We noted a lot of the roof leak damages in the second floor ceiling.

The new roof line

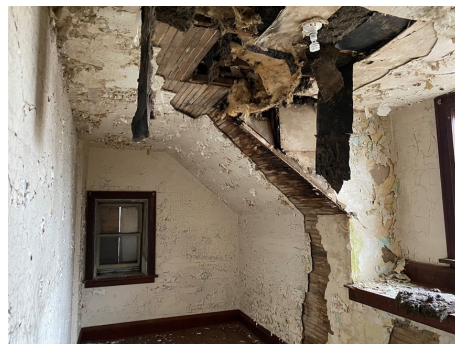
Ceiling damaged due to roof leak
