The Town of Niagara-On-The-Lake

Report: MHC-20-008 **Committee Date: June 23, 2020**

Report To: Municipal Heritage Committee
Subject: 46 Paxton Lane
Heritage Permit Application
Conservation Plan for Paxton House

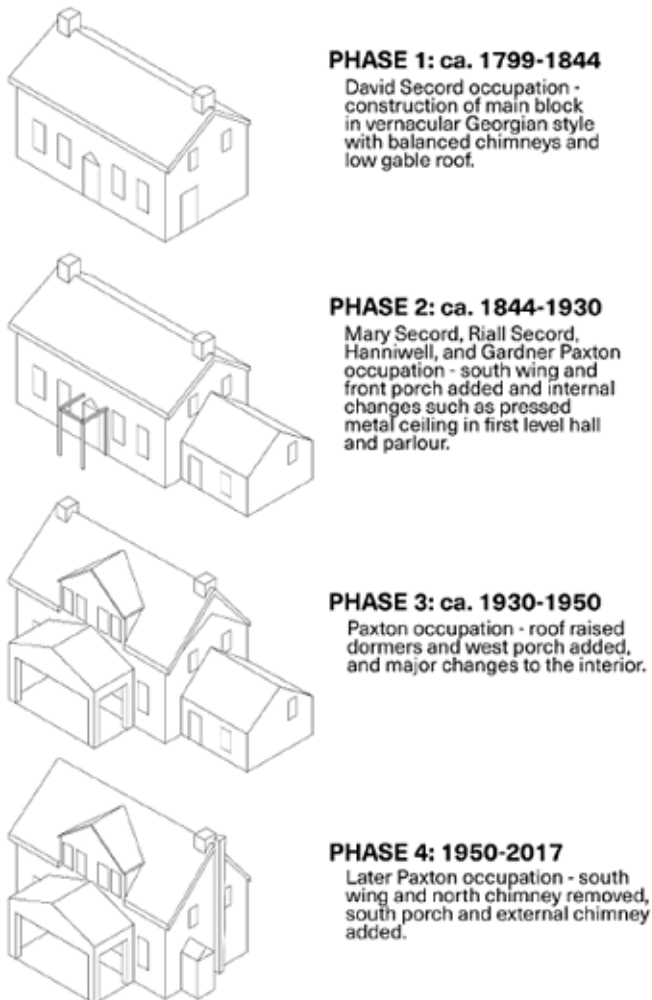
The subject property contains a 1.5 storey dwelling, which survived the 1814 burning of St. Davids. The remaining dwelling is of simple Georgian form with 5-bay facade and medium pitched roof. The dwelling has undergone significant alterations (see **Figure 2**) including a change to the roof-pitch and the addition of large gabled dormers on the east and west elevations in the 20th century (still extant). Previous additions to the dwelling are no longer extant above grade, however, early foundations remain intact underground.

Figure 2 - Phases of development and alteration to the Paxton House as illustrated in the Heritage Conservation Plan prepared by Golder, dated May 5, 2020.

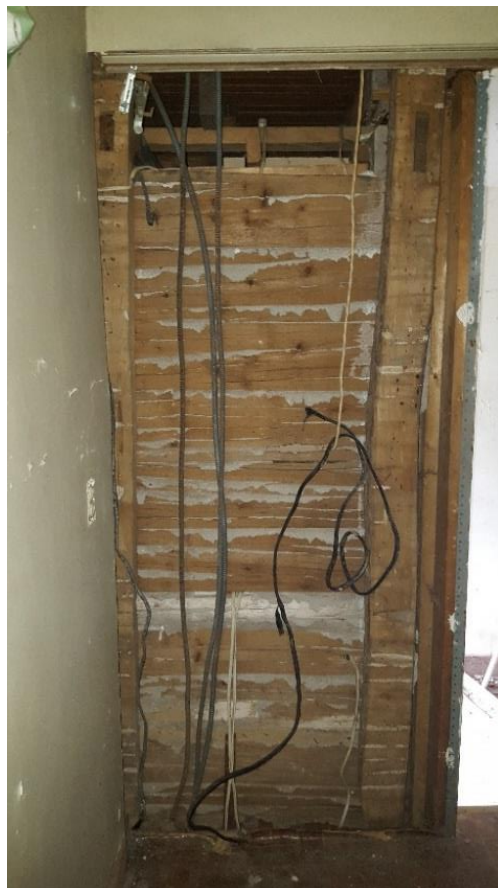
Sections of walling have been removed on a partition near the east wall, revealing hand-squared studs (with bark still adhering) that are through-mortised to take the tenons of rails, and split-board lathe-and-plaster (Figure 10). These rails are flush with the floor joists of the second level but are unlikely to be load bearing.

Figure 10: Partition of split-board lath-and-plaster between two hewn studs near the south entrance (2017).

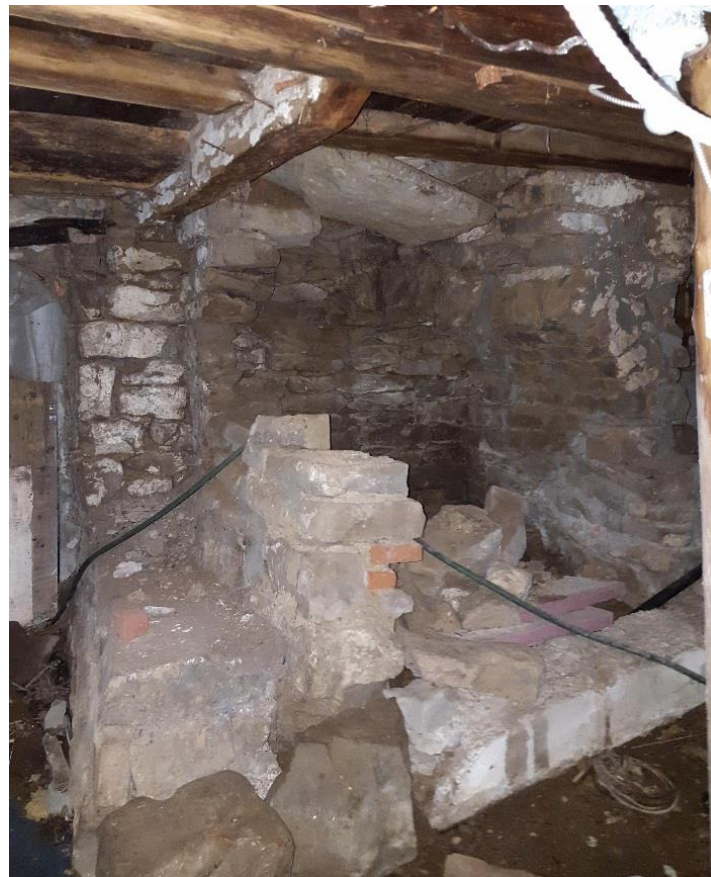
This was reported in the Golder HIA to be a hearth but is now believed to be a chimney base with relieving arch as seen in other 18th century houses (Figure 14 and Figure 15). All the flooring is exposed and includes a combination of hand-squared timbers and later sawn and finished joists, some of which are sintered to the original hewn logs.

Figure 14: Chimney base on the north foundation wall with remnants of a relieving arch at far right (2017).

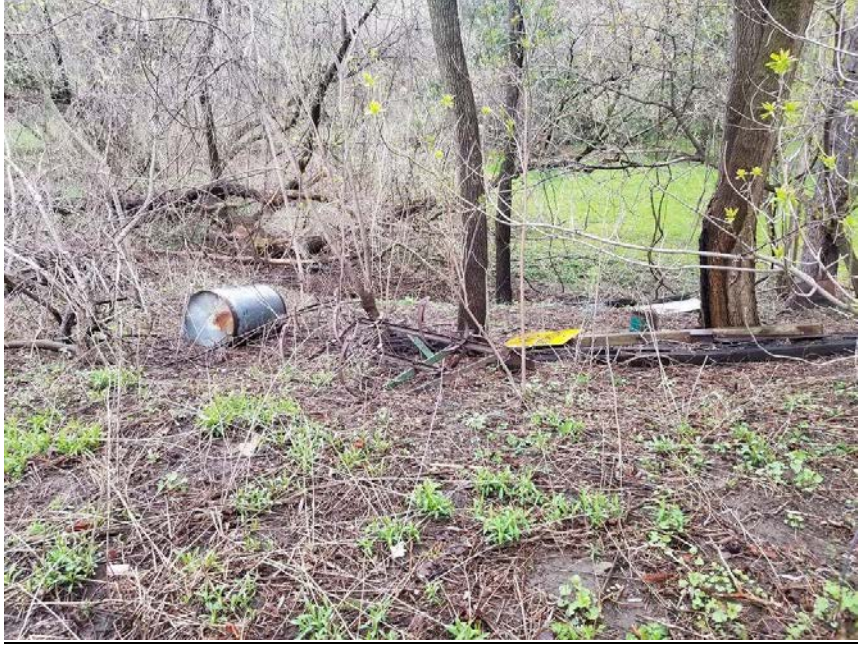
A photograph showing a wooded area with residential debris. A large, rusted metal barrel lies on the ground amidst dry brush and trees. A yellow flag is visible on the ground to the right.	Residential debris throughout the southwest corner of the study site, facing west-southwest.
6

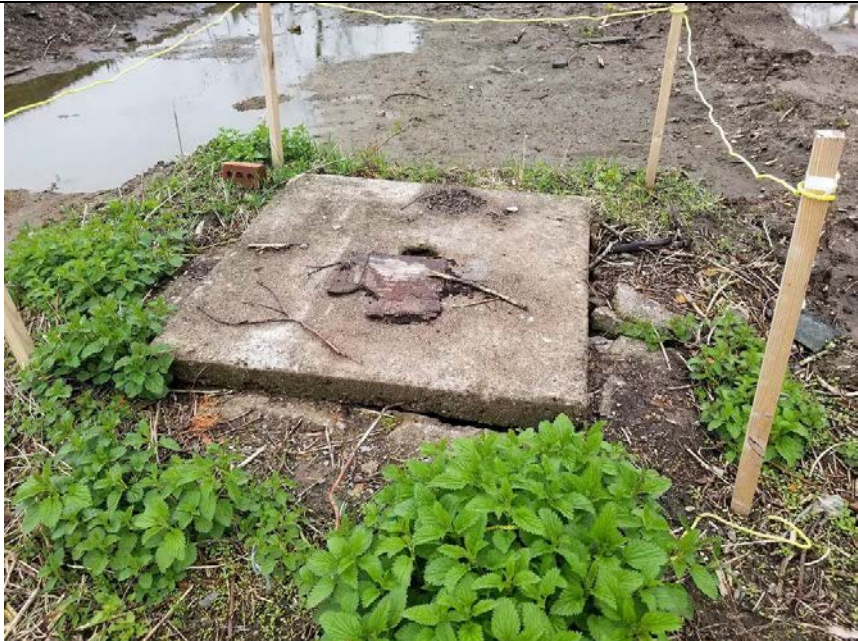
A photograph of a historical water well. A concrete slab covers the well opening, which is surrounded by green vegetation. A yellow caution tape is strung across the area, supported by wooden stakes.	Historical water well by the southeast corner of the dwelling, facing south.

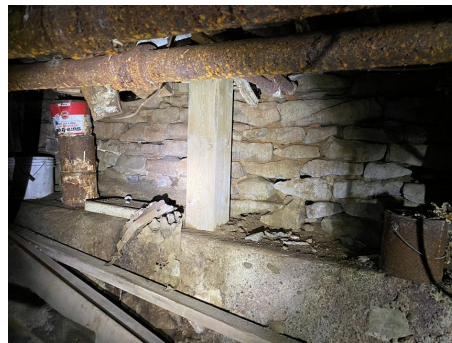
Benching at the bottom of the wall

There is little or no waterproofing in the basement. The mortar joints have been reduced to sand and have disintegrated. It's difficult to assess the strength of the existing structure but it is evident that over the years someone has tried to add more support to the building.

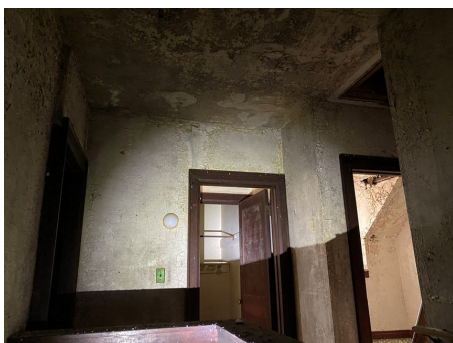
Through the existing second floor hole we measured the floor joists to be 2x10 @16". Based on our review the ground floor framing and interior walls are in relatively good structural condition. The floor structure is strong and the walls appears to be straight.

Interior partition walls

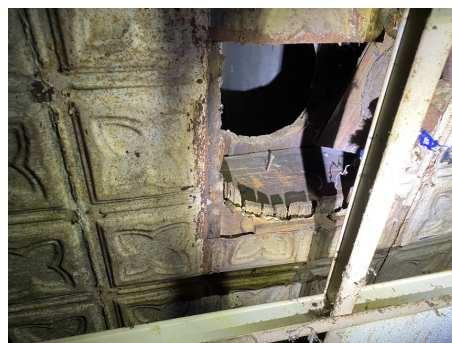
Exposed floor structure

The floor and walls appears to be in good condition, but need to be cleaned and exposed for further review.
